BUILDING-STRUCTURE INVENTORY FORM

1. BUILDING NAME(S): Vanderbilt ^{Estate: Water Tower} Clock Tower (The Artist Colony)
 2. COUNTY: Suffolk TOWN/CITY: Islip VILLAGE: Oakdale
 3. STREET LOCATION: Hollywood Avenue, South Side, at Tower Mews
 4. OWNERSHIP: a. public b. private
 5. PRESENT OWNER: Florence Bezruczyk ADDRESS: see #3
 6. USE: Original: water tower Present: residence
 7. ACCESSIBILITY TO PUBLIC: Exterior visible from public road: Yes No
 Interior accessible: Explain _____

Prepared by: Society for the Preservation of Long Island Antiquities
 Setauket, New York 11733
 Nina Monastero, Research Assistant
 May, 1979

IDLE HOUR
Wm. K. Vanderbilt West Barn
Artist's Colony

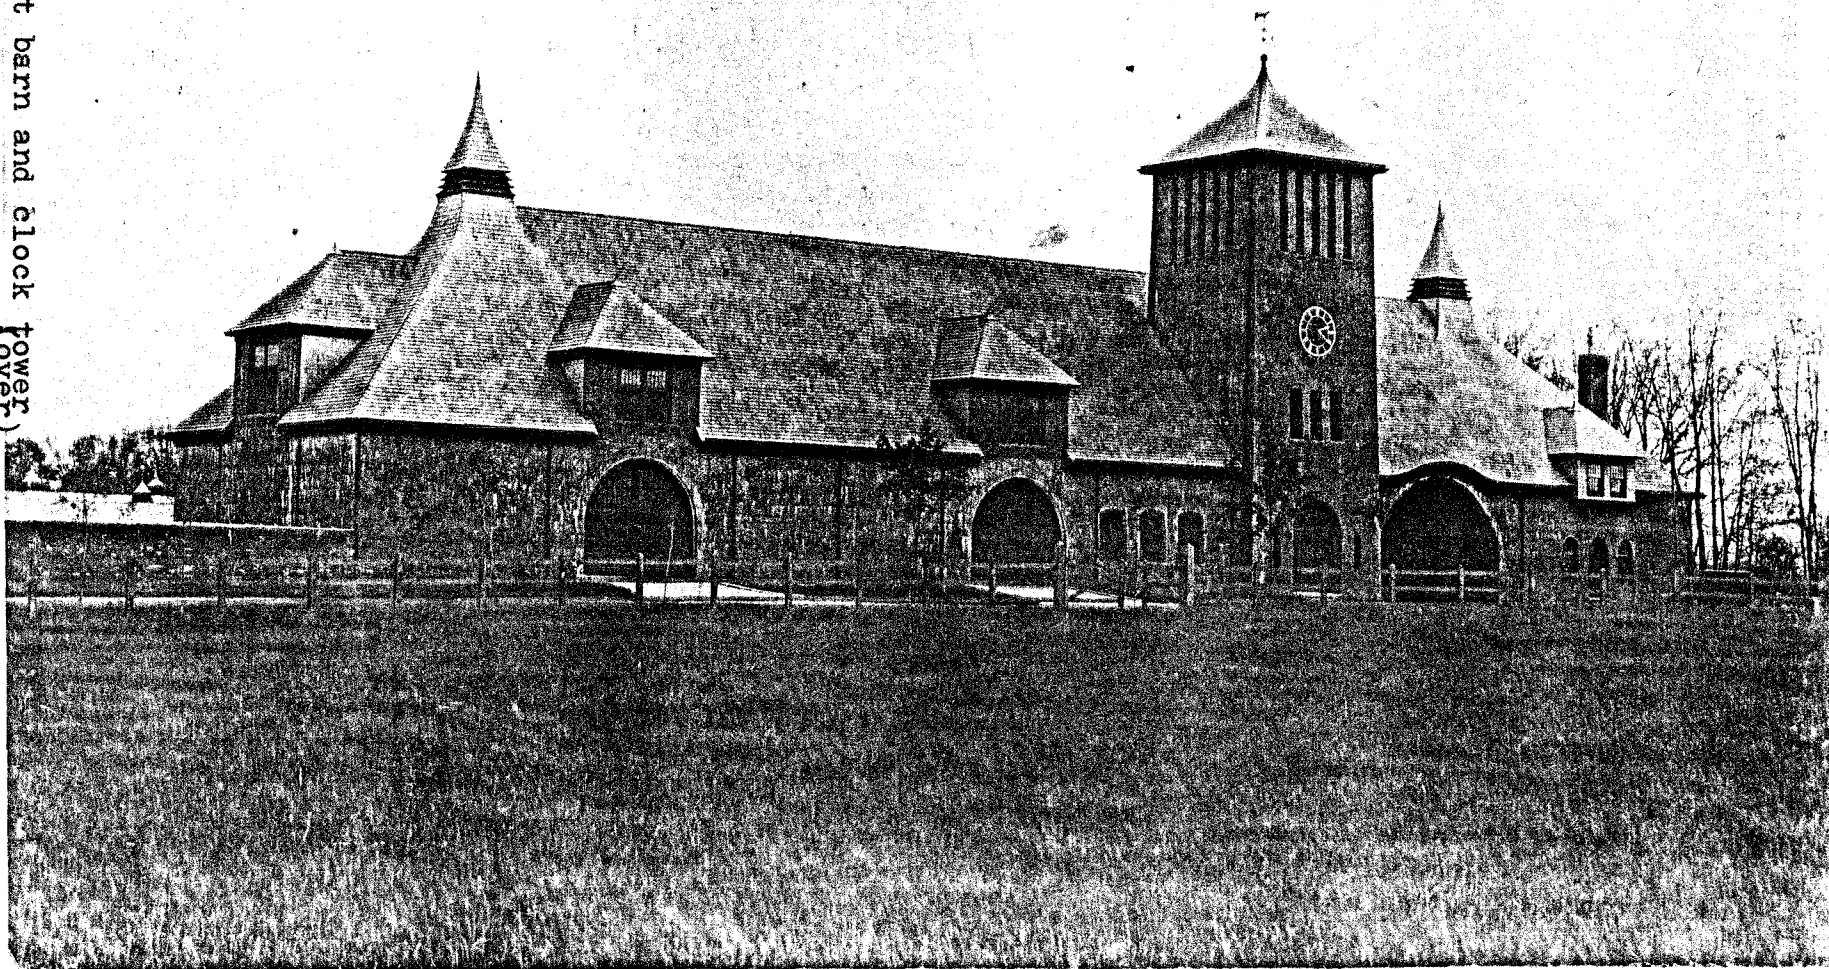
Idle Hour West barn and clock tower
From: Collection of W.K. Vanderbilt Historical Society
