BUILDING-STRUCTURE INVENTORY FORM

- 1. BUILDING NAME(S): Central Islip State Hospital's Photo Lab; Originally the
- 2. COUNTY: Suffolk TOWN/CITY: Islip VILLAGE: Central Isl. Laboratory
- 3. STREET LOCATION: East of Carleton Ave. (east of Group M Buildings)
- 4. OWNERSHIP: a. public  b. private
- 5. PRESENT OWNER: \_\_\_\_\_ ADDRESS: \_\_\_\_\_
- 6. USE: Original: Laboratory Present: Abandoned Photo Lab
- 7. ACCESSIBILITY TO PUBLIC: Exterior visible from public road: Yes  No  Permission re-  
Interior accessible: Explain By appointment only quired.

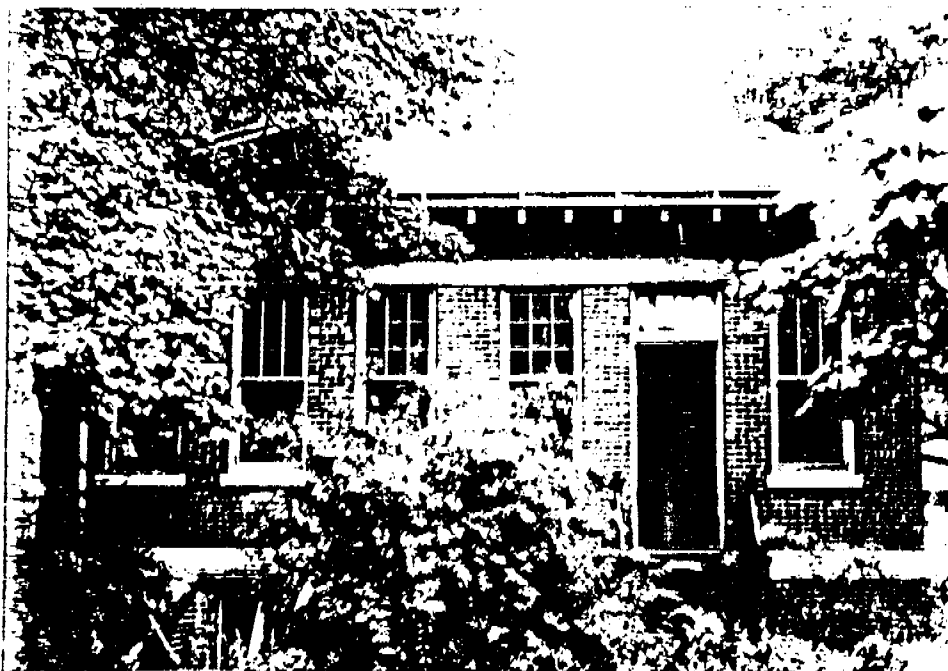
HP-1 Roll #Q7; Neg. #1  
South side

This one story brick building has a slate roof and decorative exposed rafter ends. It has a hipped roof with projecting gabled vents. The nine-over-nine windows have lugsills. There is a four pane transom above the front door. The basement is partially above ground, and has an exterior entrance.
