BUILDING-STRUCTURE INVENTORY FORM

\*\*\*\*\* Bldgs. 137-  
147

- 1. BUILDING NAME(S): Central Islip State Hospital's MacGregor & Smith Groups
- 2. COUNTY: Suffolk TOWN/CITY: Islip VILLAGE: Central Islip (M & S)
- 3. STREET LOCATION: East of Carleton Avenue, on access roads
- 4. OWNERSHIP: a. public  b. private
- 5. PRESENT OWNER: Islip ADDRESS: \_\_\_\_\_
- 6. USE: Original: Housing for patients Present: Abandoned
- 7. ACCESSIBILITY TO PUBLIC: Exterior visible from public road: Yes  No

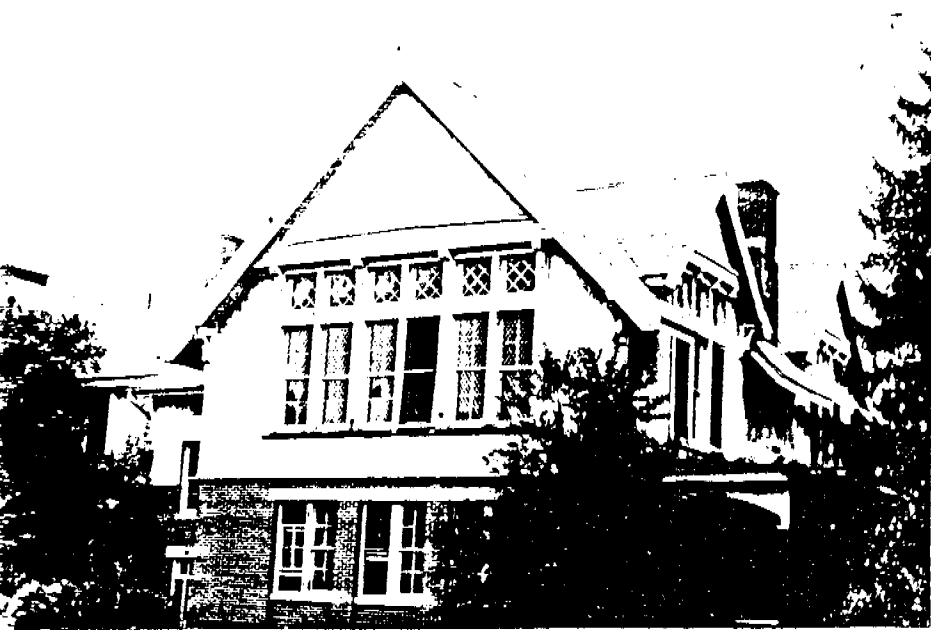
Roll #Q7; Neg. #2  
HP-1 Building in M Group

One building in Smith Group burned; one knocked down.

18. OTHER NOTABLE FEATURES OF BUILDING AND SITE (including interior features if known):  
 These Tudor Revival Buildings are primarily two and one-half stories, with brick first stories, and stucco second stories. Each group contains a one and one-half story building which was used as kitchen and dining room.
