BUILDING-STRUCTURE INVENTORY FORM

1. BUILDING NAME(S): Vanderbilt Sheds ^{EACH:} (The Artist Colony)
 2. COUNTY: Suffolk TOWN/CITY: Islip VILLAGE: Oakdale
 3. STREET LOCATION: 21-29 Jade Street
 4. OWNERSHIP: a. public b. private
 5. PRESENT OWNER: various ADDRESS: _____
 6. USE: Original: Sheds Present: residences, shed
 7. ACCESSIBILITY TO PUBLIC: Exterior visible from public road: Yes No
 Interior accessible: Explain

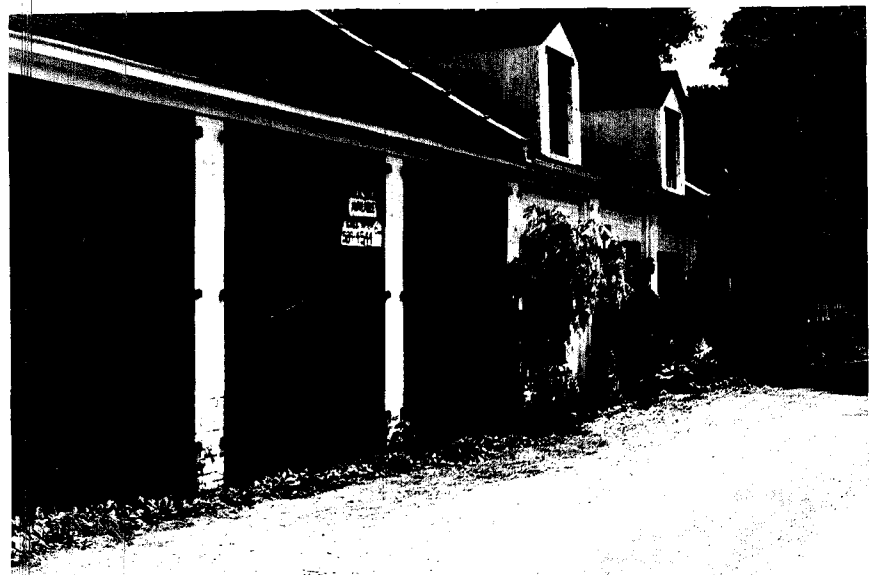
12. PHOTO: Neg. 33, west facade
NJM-1

8. BUILDING MATERIAL: a. clapboard b. stone c. brick d. board and batten
 e. cobblestone f. shingles g. stucco other: _____
 9. STRUCTURAL SYSTEM: a. wood frame with interlocking joints
 (if known) b. wood frame with light members
 c. masonry load bearing walls
 d. metal (explain) _____
 e. other _____
 10. CONDITION: a. excellent b. good c. fair d. deteriorated
 11. INTEGRITY: a. original site b. moved if so, when? _____
 c. list major alterations and dates (if known):
three bays have brick infill

18. OTHER NOTABLE FEATURES OF BUILDING AND SITE (including interior features if known):
 Seven bay shed of brick piers. Originally large wooden doors hung from piers, now only 3 pairs remain with original hardware. Remaining bays of 1 story brick piers have brick infill and gable roof dormers.
