BUILDING-STRUCTURE INVENTORY FORM

1. BUILDING NAME(S): Vanderbilt ^{Estate:} Chicken-Tender's House (Artist Colony)
 2. COUNTY: Suffolk TOWN/CITY: Islip VILLAGE: Oakdale
 3. STREET LOCATION: Jade Street; East side; at Featherbed Ln.
 4. OWNERSHIP: a. public b. private
 5. PRESENT OWNER: Scheldorn ADDRESS: see #3
 6. USE: Original: residence Present: residence
 7. ACCESSIBILITY TO PUBLIC: Exterior visible from public road: Yes No
 Interior accessible: Explain _____

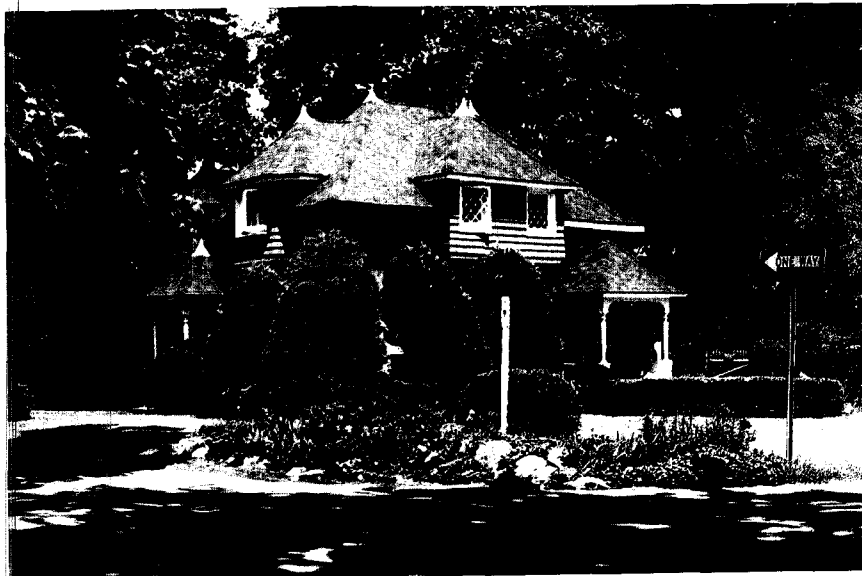
12. PHOTO: Neg. 17, from southeast
NJM-1

18. OTHER NOTABLE FEATURES OF BUILDING AND SITE (including interior features if known):
 1½ story brick house with a hip roof. The house is in the Queen Anne style with oriel windows that have hip roofs. The original stoop with turned posts in its portico survives. There are segmental arched window and door openings with granite sills and a granite stringcourse.
