**BUILDING-STRUCTURE INVENTORY FORM**

- 1. BUILDING NAME(S): ~~Fritzsche House (Formerly Ashby)~~
- 2. COUNTY: Suffolk TOWN/CITY: Islip VILLAGE: Bayport
- 3. STREET LOCATION: 380 Middle Rd., south side, east of Bay Ave.
- 4. OWNERSHIP: a. public  b. private
- 5. PRESENT OWNER: Robert Fritzsche ADDRESS: 380 Middle Rd., Bayport
- 6. USE: Original: residence Present: residence
- 7. ACCESSIBILITY TO PUBLIC: Exterior visible from public road: Yes  No   
Interior accessible: Explain by appointment

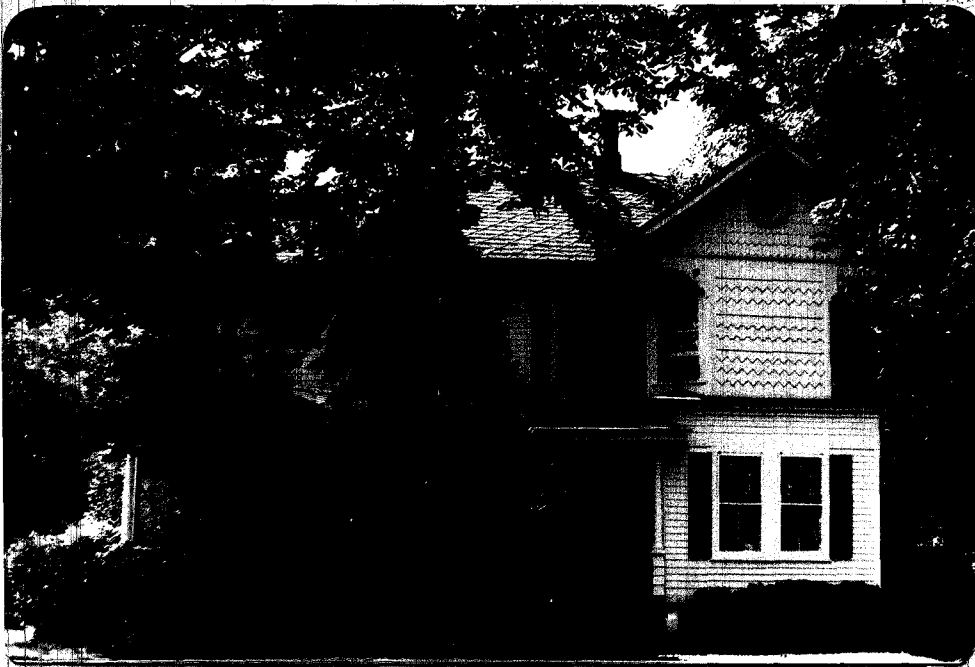
12. PHOTO: ELW I, # 8 A  
from N, front

**Two and one-half story, irregular-shaped, clapboard, Queen Anne house with jerkin-headed main roof. Front gabled bay with clipped corners and decorative shingles at second floor level. Scalloped shingles at third floor level on all sides including gables. Garage gable matches. Unevenly-spaced panes in upper sash over two panes in lower sash. Interesting porch with projecting pavillion. Brick foundation. House belonged to A hby in 1915.**
