**BUILDING-STRUCTURE INVENTORY FORM**

DIVISION FOR HISTORIC PRESERVATION  
NEW YORK STATE PARKS AND RECREATION  
ALBANY, NEW YORK (518) 474-0479

- 1. BUILDING NAME(S): Building 43-Administration Building
- 2. COUNTY: Suffolk TOWN/CITY: Islip VILLAGE: Central Islip
- 3. STREET LOCATION: east side of Carleton Ave.
- 4. OWNERSHIP: a. public  b. private
- 5. PRESENT OWNER: New York State ADDRESS: \_\_\_\_\_
- 6. USE: Original: Administration Present: Post Office
- 7. ACCESSIBILITY TO PUBLIC: Exterior visible from public road: Yes  No   
Interior accessible: Explain \_\_\_\_\_

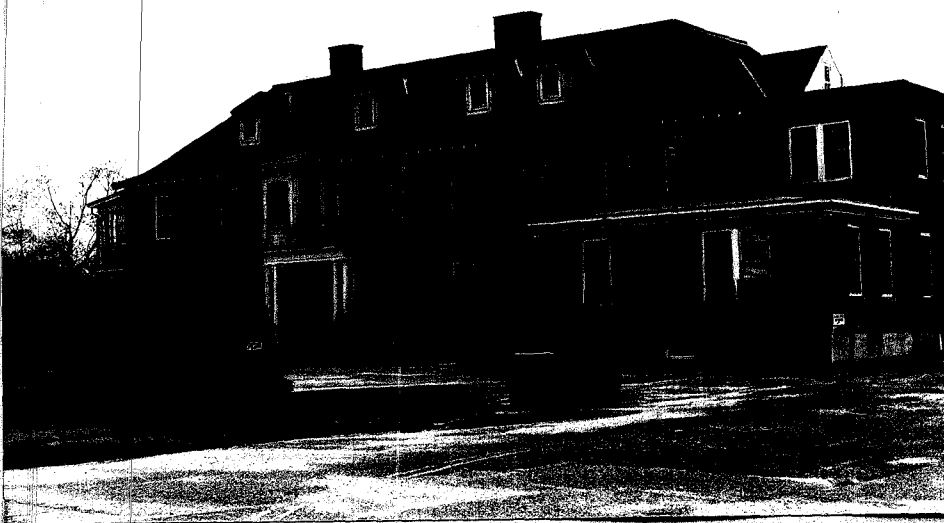
12. PHOTO: CI-WHC-r-1,36 from SE

The building is a 2-story brick Colonial-Revival building with entrance on all four elevations, 3 bays on the west facade and 9 bays on the north & south facades. Truncated hip roof, flaring out at eaves over exposed rafter ends with dutch parapet facade gables on north and west facades. Hip roof dormers also with exposed rafter ends. Double deck porch on west facade with paired tuscan columns. Brick arched window heads with granite keystones and sills. Granite water table. A 2-story bay window on south facade.

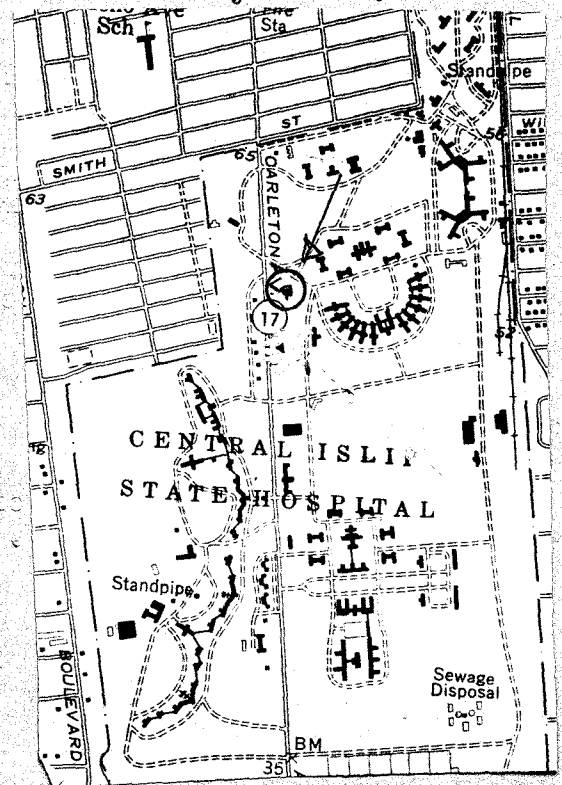
- 8. BUILDING MATERIAL: a. clapboard  b. stone  c. brick  d. board and batten   
e. cobblestone  f. shingles  g. stucco  other: \_\_\_\_\_
- 9. STRUCTURAL SYSTEM: (if known) a. wood frame with interlocking joints   
b. wood frame with light members   
c. masonry load bearing walls   
d. metal (explain) \_\_\_\_\_  
e. other \_\_\_\_\_
- 10. CONDITION: a. excellent  b. good  c. fair  d. deteriorated
- 11. INTEGRITY: a. original site  b. moved  if so, when? \_\_\_\_\_  
c. list major alterations and dates (if known):  
2 story, flat roof addition on west has been added.

The building is located on the east side of Carleton Avenue, right off the road.
