BUILDING-STRUCTURE INVENTORY FORM

- BUILDING NAME(S): Central Islip State Hospital's Hoffman House
- COUNTY: Suffolk TOWN/CITY: Islip VILLAGE: Central Islip
- STREET LOCATION: East side of Carleton Ave., south of Administration Bldg.
- OWNERSHIP: a. public b. private
- PRESENT OWNER: _____ ADDRESS: _____
- USE: Original: Staff building Present: _____
- ACCESSIBILITY TO PUBLIC: Exterior visible from public road: Yes No
Interior accessible: Explain By appointment only

SIGNIFICANCE19. DATE OF INITIAL CONSTRUCTION: 1911ARCHITECT: Franklin B. Ware, State Arch.

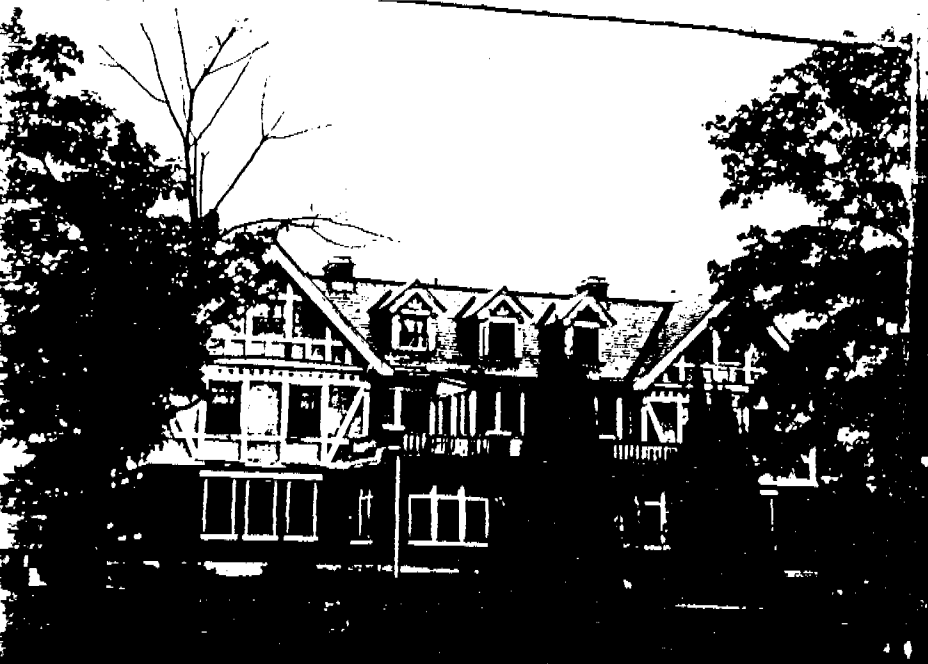
HP-1 Roll #Q7; Neg. #4
Front (West) View.

There are two gabled bays flanking the center section; the center section has three gabled dormers. At the first story the center section projects, and has a terrace above.

This two and one-half story Tudor Revival building has a brick first story; the second story is stucco with half-timbering. There is a segmental arched front entrance with a transom and flanking windows. The gable windows have diamond-shaped panes; there are drops in the gable peaks. The side eaves have exposed rafter ends. The front dormers have stickwork; there are shed-roofed dormers on the sides. The roof is slate.
