**BUILDING-STRUCTURE INVENTORY FORM**

1. BUILDING NAME(S): Building #7
2. COUNTY: Suffolk TOWN/CITY: Islip VILLAGE: Central Islip
3. STREET LOCATION: east side of Carleton Ave.
4. OWNERSHIP: a. public  b. private
5. PRESENT OWNER: New York State ADDRESS: \_\_\_\_\_
6. USE: Original: \_\_\_\_\_ Present: \_\_\_\_\_
7. ACCESSIBILITY TO PUBLIC: Exterior visible from public road: Yes  No   
 Interior accessible: Explain \_\_\_\_\_

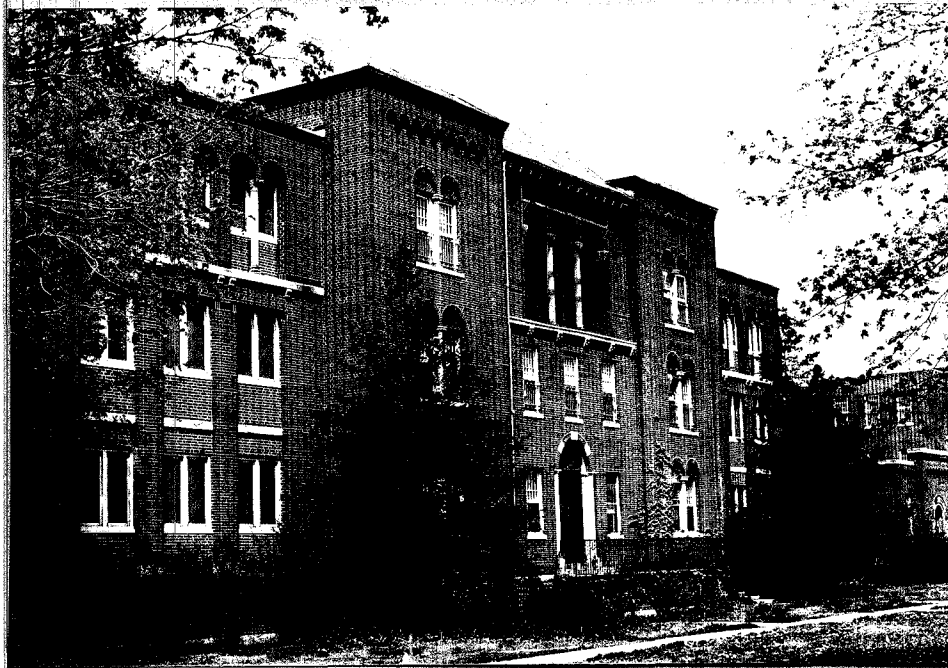
12. PHOTO: CI-WHG-r-1, 14 from SW

HP-1 THE SOUTH FACADE OF THE WEST WING.  
 ONE-STORY ENTRANCE IS SEEN AT FAR  
 RIGHT.
