BUILDING-STRUCTURE INVENTORY FORM

YOUR NAME: B. Van Liew, Consultant/ NSF DATE: 8/79
N Sherrill Foster
 YOUR ADDRESS: Box 416, St. James, L.I. TELEPHONE: 516-589-5600
 ORGANIZATION (if any): Natural Heritage Trust

1. BUILDING NAME(S): East Bath House Heckscher State Park
 2. COUNTY: Suffolk TOWN/CITY: Islip VILLAGE: East Islip
 3. STREET LOCATION: Timber Point Rd; South side 7 all: Heckscher Pkwy.
 4. OWNERSHIP: a. public LISPC b. private ADDRESS: Belmont State Park
 5. PRESENT OWNER: _____ ADDRESS: _____
 6. USE: Original: Bath House Present: closed
 7. ACCESSIBILITY TO PUBLIC: Exterior visible from public road: Yes No
 Interior accessible? Explain: Public Use

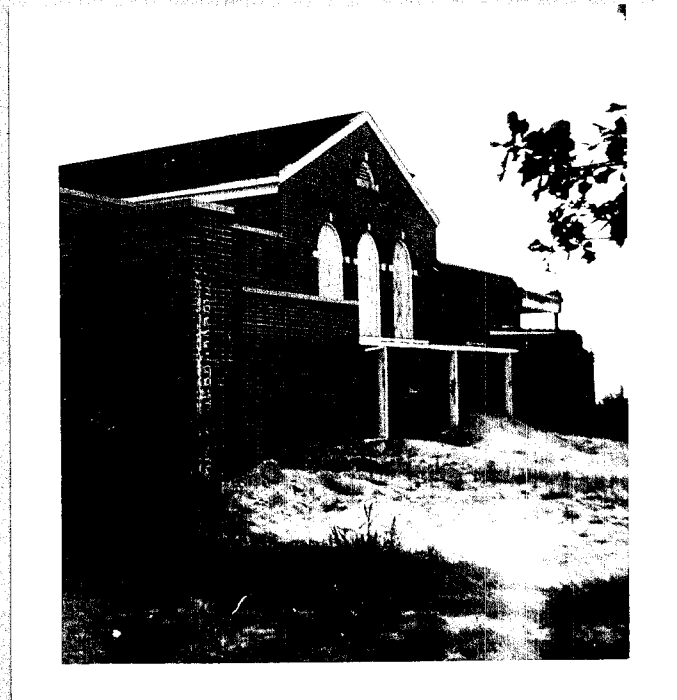
12. PHOTO: Roll 2
H2 - 1 East facade

Building has been vandalized by fire, etc, and faces a contaminated area of the beach

5 bay 1½ story gable roof red brick building with pergola porch with pilasters and round tuscan columns as support. Round windows in upper section with 4 equidistant keystones.
