BUILDING-STRUCTURE INVENTORY FORM

- BUILDING NAME(S): (Castle Inn)
- COUNTY: Suffolk TOWN/CITY: Islip VILLAGE: _____
- STREET LOCATION: Main St ; south side ; west of Bayon Ave. n and Bryon St.
- OWNERSHIP: a. public b. private
- PRESENT OWNER: _____ ADDRESS: _____
- USE: Original: Residence Present: Restaurant and catering hall
- ACCESSIBILITY TO PUBLIC: Exterior visible from public road: Yes No
Interior accessible: Explain _____

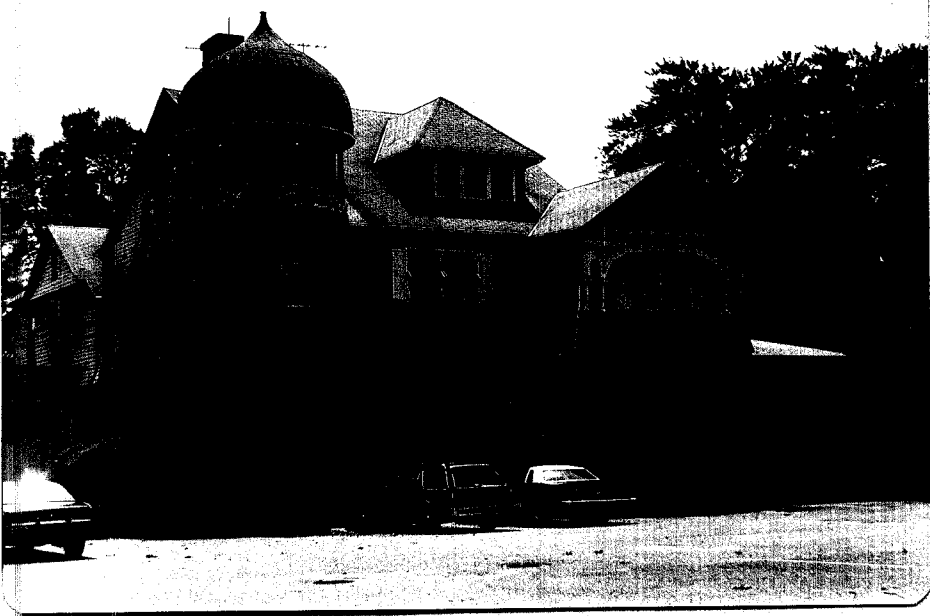
12. PHOTO: LOOKING SW

18. OTHER NOTABLE FEATURES OF BUILDING AND SITE (including interior features if known):
Interior: Original front entry doors: heavy wood with brass hardware;
Main floor: restaurant & catering facilities; original woodwork & trim on windows and doors; 2nd floor: Wedding reception area, apartments; original door surrounds; 3rd floor: apartments. Original staircase with heavy wood railings and balustrade; original stained glass and crystal windows.

20. HISTORICAL AND ARCHITECTURAL IMPORTANCE:
Exterior: Queen Anne house; 2 story round bay at NE corner with helmet roof tower; paired marble columns below tower; ~~incised~~ decorated frieze under marble columns; stone chimney; porte cochere; gables with plaster decoration; round shingles on corners of gables; Original Creamer fence survives on South Bay Ave. on East side South to Richardson Lane.

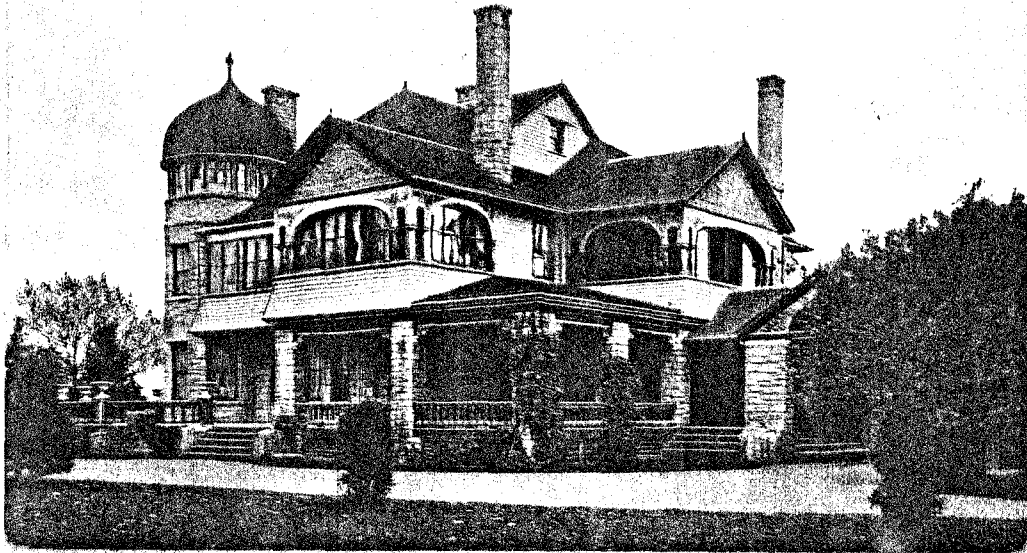
Residence of F. D. Creamer, Islip, L. I.

1915 map: 2½ story house and 2 related outbuildings owned by Frank Creamer Estate
According to one source, house was built in 1877 for Frederick W. Taylor and was later acquired by the Creamers. (?)
