BUILDING-STRUCTURE INVENTORY FORM

YOUR NAME: Town of Islip DATE: 13 August 1976 JUN 21 1977  
Town Hall  
YOUR ADDRESS: 655 Main Street TELEPHONE: 516 581-2000  
Islip, L.I., N.Y. 11751  
ORGANIZATION (if any): Department of Planning, Housing & Development

- 1. BUILDING NAME(S): (Overton Funeral Home, Inc.)
- 2. COUNTY: Suffolk (TOWN) CITY: Islip VILLAGE: \_\_\_\_\_
- 3. STREET LOCATION: 172 Montauk Highway; corner Athasca Rd. & Montauk Hwy.
- 4. OWNERSHIP: a. public  b. private
- 5. PRESENT OWNER: \_\_\_\_\_ ADDRESS: \_\_\_\_\_
- 6. USE: Original: Residence Present: Funeral Home
- 7. ACCESSIBILITY TO PUBLIC: Exterior visible from public road: Yes  No   
Interior accessible: Explain no

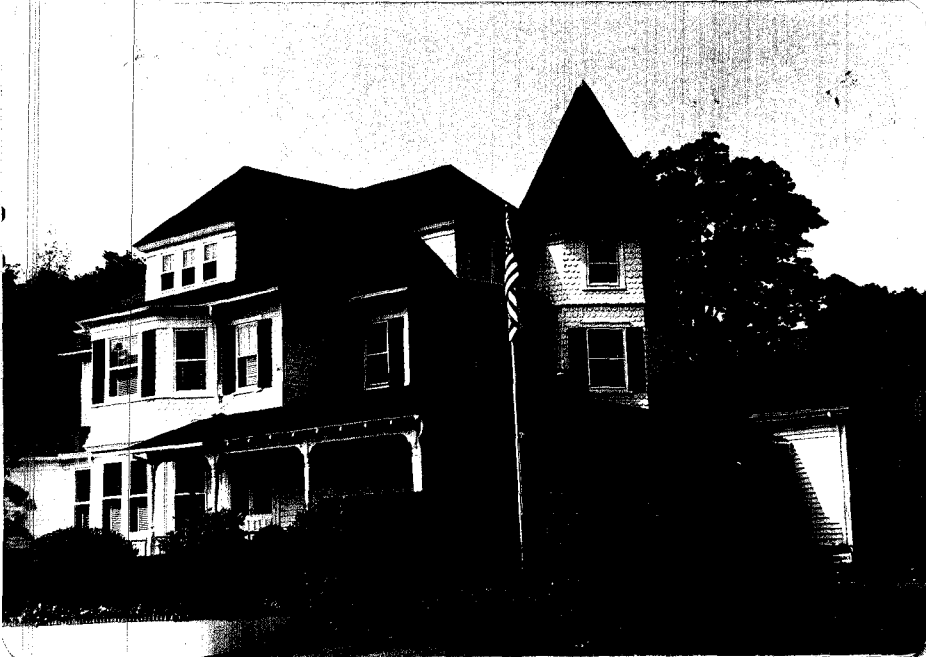
12. PHOTO: LOOKING SW

This adaptive use preserves 90% of original integrity.  
West wing added circa 1960; carport gone.

18. OTHER NOTABLE FEATURES OF BUILDING AND SITE (including interior features if known):  
Exterior: Original front porch with brackets and turned posts; sawn decoration on rafter ends under eaves; some original clapboards; bay on 2nd and 3rd floors with steeply pointed octagonal roof; 2 story bay on East side; corbelled brick chimney; fishscale shingles survive on gables, dormers, towers, original back porch with turned posts on rear extension.
