**BUILDING-STRUCTURE INVENTORY FORM**

- 1. BUILDING NAME(S): Toolhouse and Potting Shed
- 2. COUNTY: Suffolk TOWN/CITY: Islip VILLAGE: Oakdale
- 3. STREET LOCATION: 162 Central Blvd.
- 4. OWNERSHIP: a. public  b. private
- 5. PRESENT OWNER: \_\_\_\_\_ ADDRESS: see #3
- 6. USE: Original: Toolhouse and shed Present: residence
- 7. ACCESSIBILITY TO PUBLIC: Exterior visible from public road: Yes  No   
Interior accessible: Explain \_\_\_\_\_

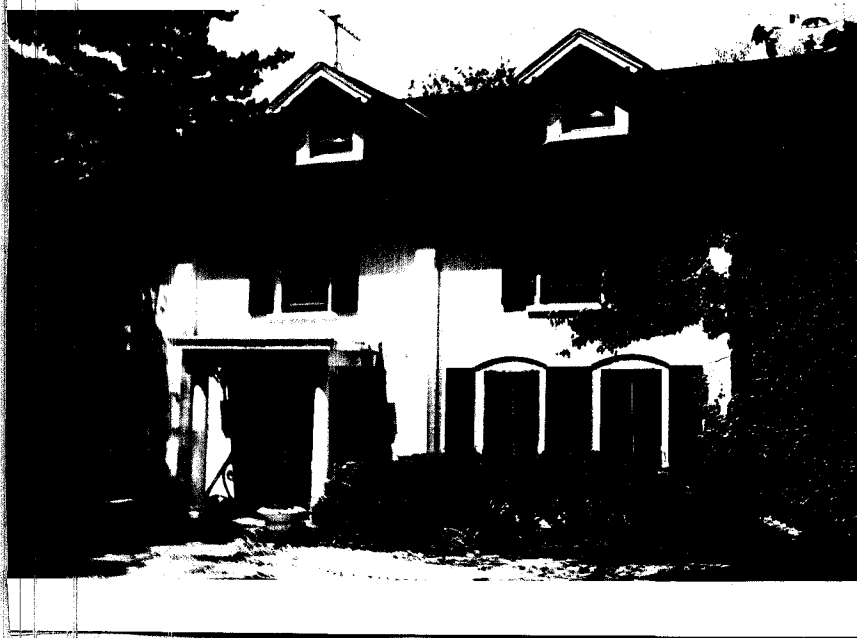
12. PHOTO: Neg. 8, East facade  
NJM-1

18. OTHER NOTABLE FEATURES OF BUILDING AND SITE (including interior features if known):  
 2½ story brick structure of four bays. Topped by a hip roof, this building has two gable roof dormers with 2 over 2 windows. The brickwork features buttresses and segmental arches over window and door openings.
